# COMMUNITY BASED LANDFILL MONITORING

**F. Kölsch, K. Fricke**

## ABSTRACT

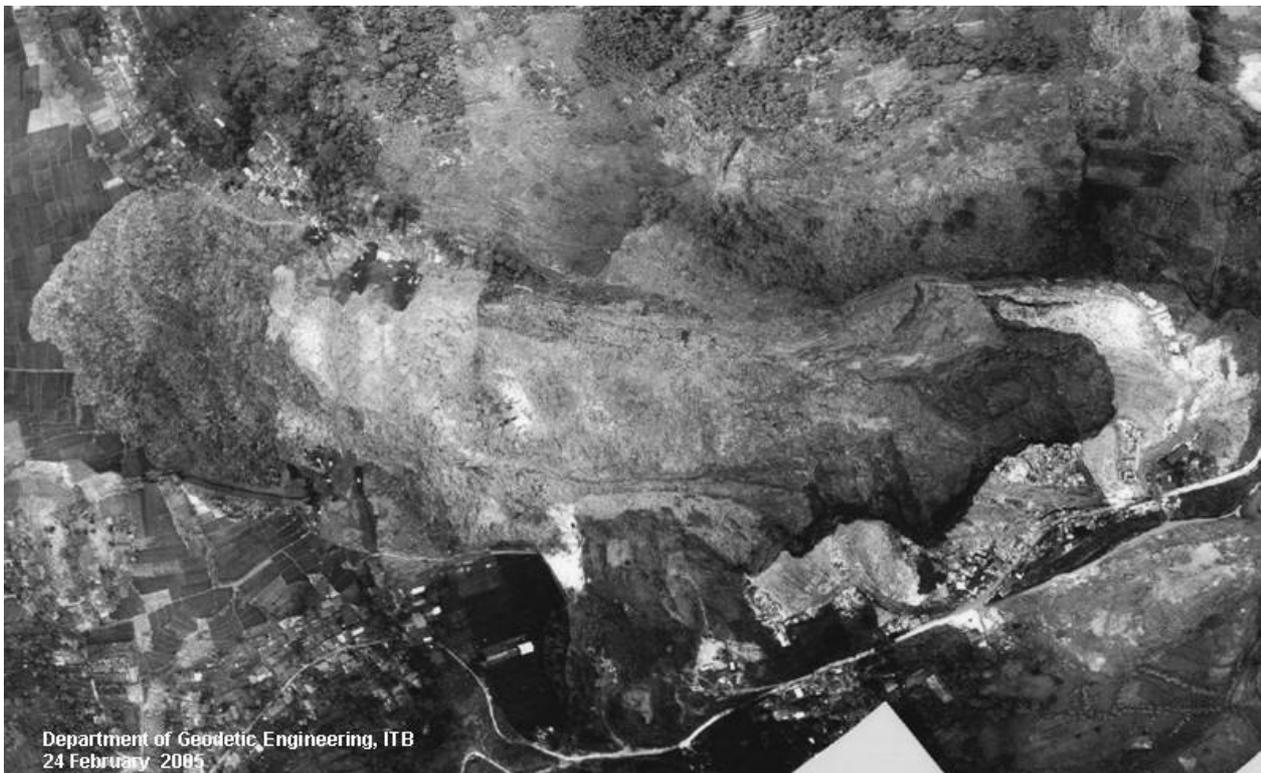
Figure 1: Satellite images of Leuwigajah dumpsite (taken by Bandung Institute of Technology)

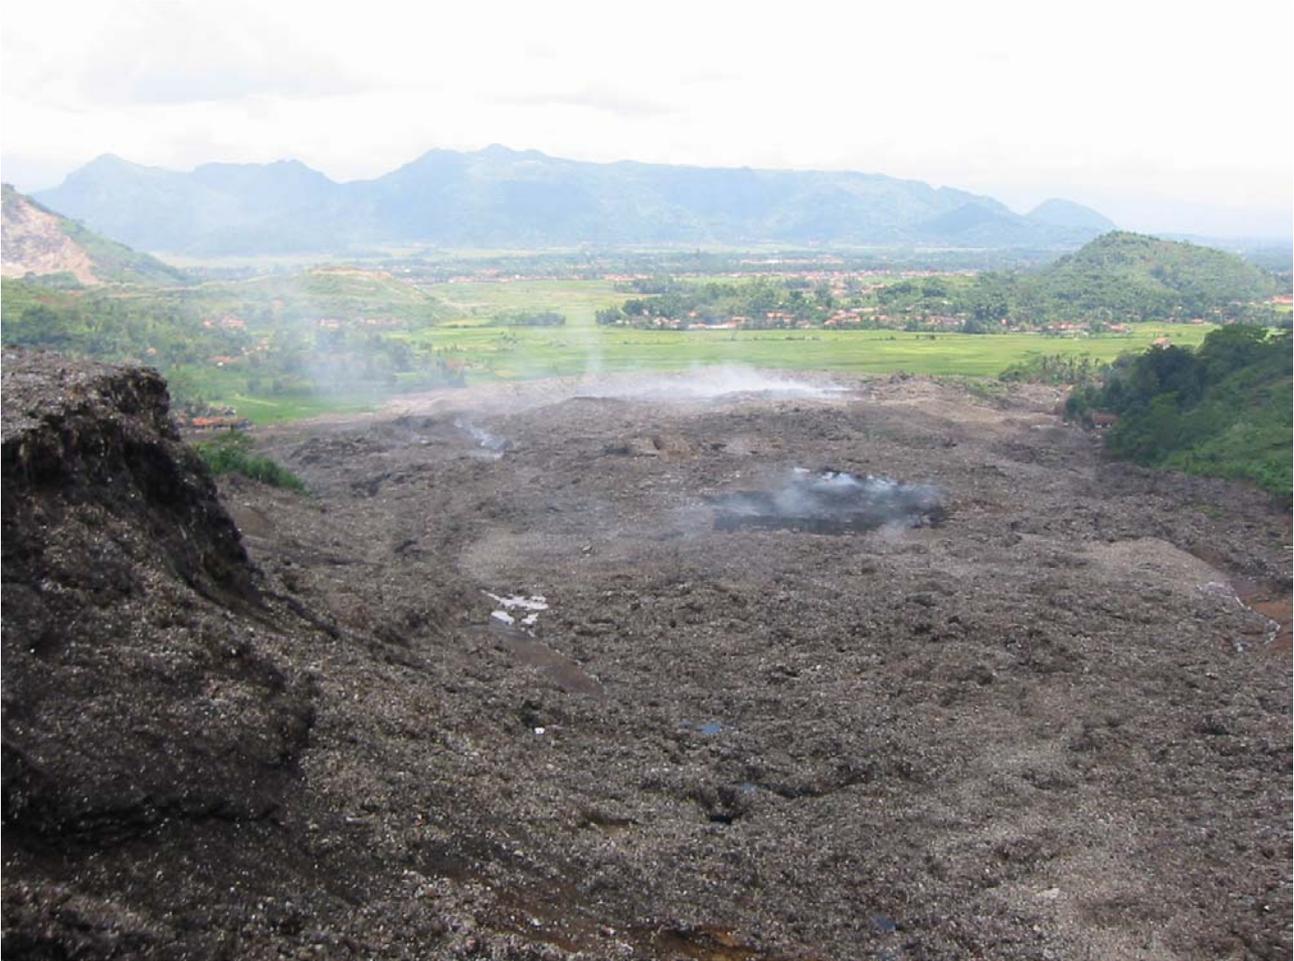
The landslide happened on February 21<sup>st</sup>, 2005 at 2.00 A.M. After 3 days of heavy rain, 2.7 million cubic meters of waste started sliding down the valley. The waste covered a 200-250 m wide stripe on a length of 900 m. It is not finally clear how quick the landslide occurred. It seems to be very likely, that it took not more than a few minutes. Witnesses reported a roll of thunder somehow like an explosion. Regarding the speed, those observations indicate that the waste came down quite similar an avalanche. The death toll was high. Down the valley one small settlement was destroyed by half (see figure 1, close to upper left corner), another village faced light damages. Rescue teams uncovered 147 dead bodies out of the waste. Rescue activities have been carried out only in the area close to the two settlements. It is not clear, whether there were people staying overnight on top of the dumpsite, which probably were killed in other areas. Figure 1 shows a satellite image generated by the Department of Geodetic of the Bandung Institute of Technology (ITB). The winding line in the right side of the image, which splits the dark and the light area, indicates the edge of the remaining slope. The former borderline of the dumpsite can be imagined by a straight line starting on the lower end of the existing slope. The centre part of the image shows the valley now covered by waste. Following the waste far to the left, surrounding untouched rice fields can be seen. The image indicates that the area now covered by waste have 4-5 times the size of the area where the waste originally was placed. Rescue works last for about 3 weeks. They were massively hindered by landfill fires. No survivors could be found. Figure 2 shows the valley after the catastrophe.

Figure 2. Leuwigajah valley after the landfill failure – downhill view

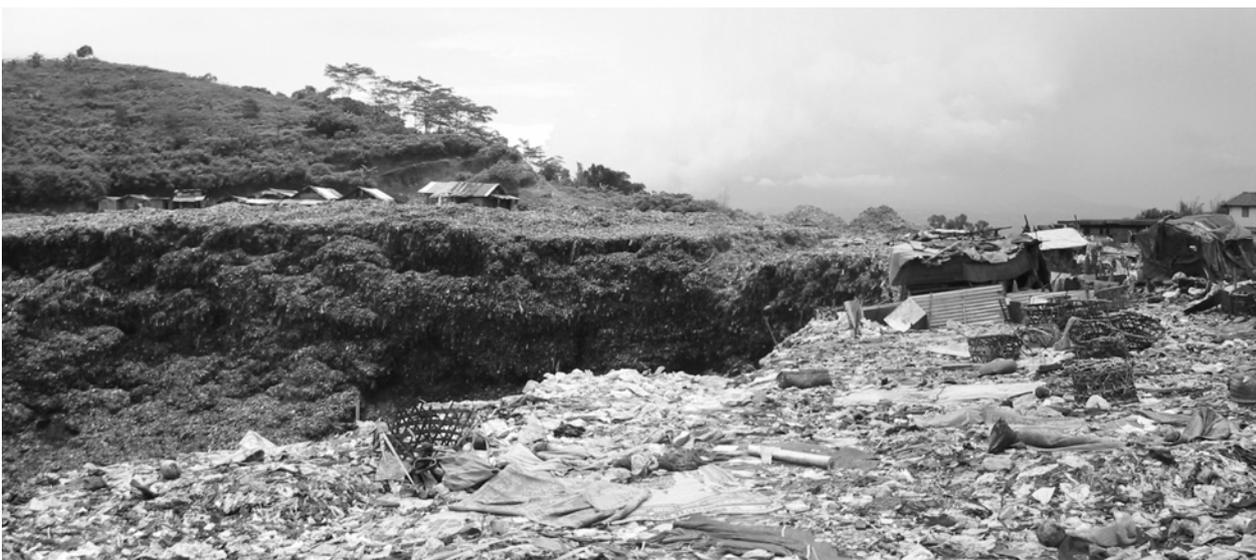
The quest, what weakened the waste strength to allow a shear failure, could be revealed. Figure 3 shows the crest of the remaining slope. It is curious to see, that the huts, where scavengers stayed during the day or lived overnight, cluster in some areas while others are free from any civil constructions. The experts suspected that smoke and smell from smouldering landfill fires may have expelled the scavengers from certain areas. Operator's staff confirmed that the landfill was burning regularly and for months. Though there was no access to the lower part of the waste cliff, some areas of the open vertical slope looked burned.

Figure 3. Slope crest with civil constructions clustering on the right and in the back

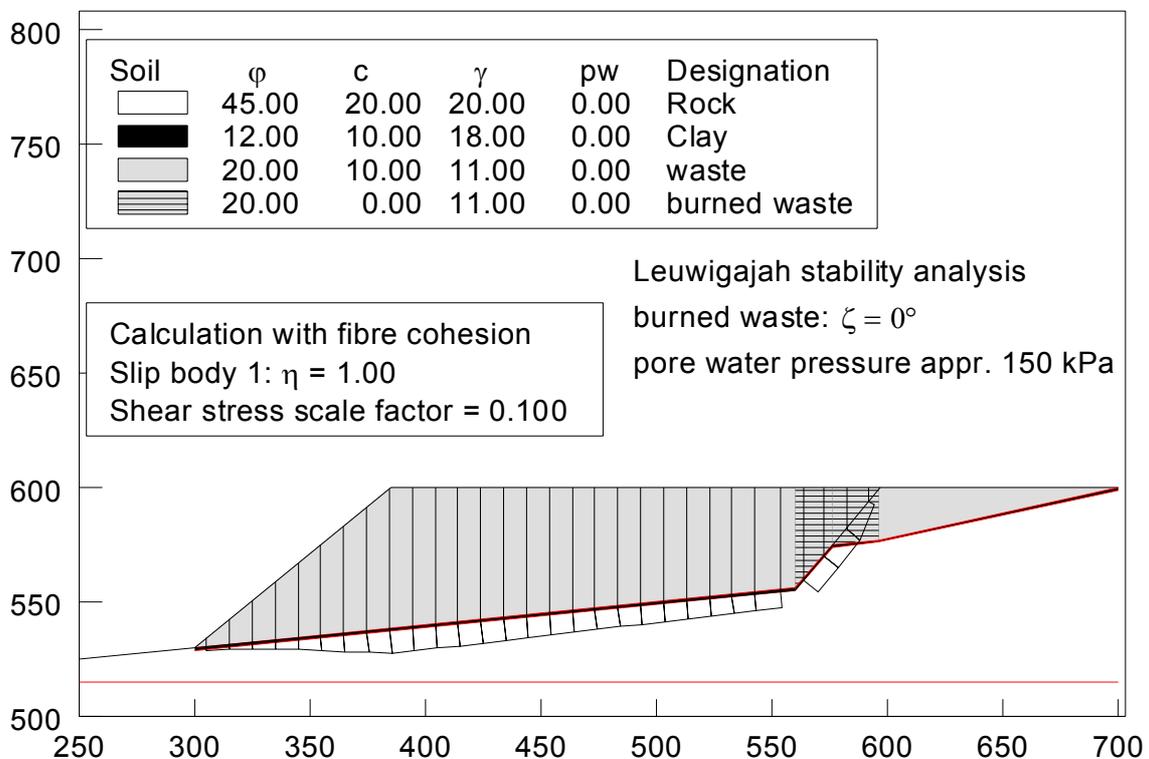
The results of the stability calculations for the Leuwigajah failure is displayed in figure 4. The impact of heavy rain has been considered by assuming a pore water pressure in the subsoil reducing the effective stress by approximately 150 kPa. The shape of the sliding figure corresponds with the situation found on site. Hundreds of alternative sliding figures have been calculated, particularly those forming shear planes through the waste. However, the most unfavourable one is that one shown in figure 4. The figure shows the situation after the landfill fire had destroyed the reinforcement particles in the upper part of the landfill. It was assumed that all tension based components of shear resistance (tensile angle  $\zeta$  and cohesion  $c$ ) have been cut down to zero. Friction components were considered not to be concerned. Compared to the modelling of unburned waste, the overall stability dropped down from 1,13 to 1,00, the dumpsite becomes instable.

Figure 4: Stability analysis for Leuwigajah dumpsite

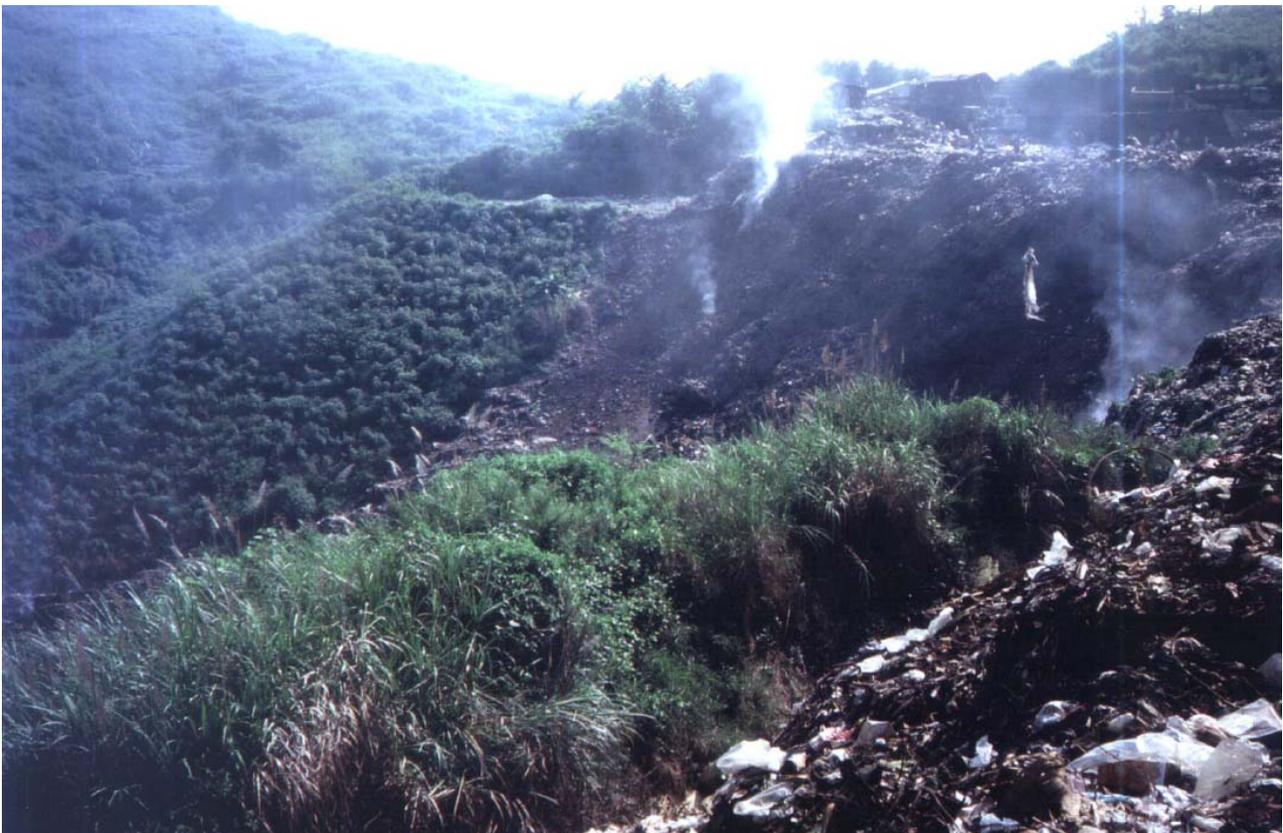
Regarding the operation, the message is perfectly clear: landfill fires can not be accepted. “Smoking mountains” are well known in poor countries, but the risk of disasters is enormous. Landfill fires require immediate fire fighting actions, smoke and smell should be recognized as a serious sign of alert not as an ugly, but common attitude of landfill operations. There various factors enabling the set-up of landfill fires. One important factor is the compaction of waste: landfill fires become more likely, if the waste is not compacted. The wide-spread drop-off procedure is extremely dangerous. Figure 5 shows the beginning of waste dumping in Leuwigajah in 1992. It perfectly illustrates the endemic fire problem

Figure 5. Opening of Leuwigajah dumpsite 1992 (by Oeltzschner)
